**F**OREST Cover Proved a Controlling Factor in Flood Prevention Man's mistreatment of the soil or of its natural forest or other vegetative cover as a cause of increasingly destructive erosion has been convincingly pointed out by studies recently conducted by the Forest Service in California. In these studies large soil tanks and  $\frac{1}{40}$ -acre plots in the mountains produced evidence that vegetation not only obstructs and retards the run-off of surface water, but also, by means of the leaf litter, and the action of the roots, keeps the topsoil so porous that a large proportion of rain water percolates continuously into the soil to join underground supplies. Litter-covered soil was found to absorb 5 to 10 times as much water as that absorbed by bare soil. Run-off was just the reverse—10 to 30 times as great from bare soil as from litter-covered soil. Generally 100 to 1,000 times more soil was swept away from bare soil plots than was eroded from forest-covered plots, and the rate of erosion increased as the intensity of rainfall increased.

sponsible for numerous highly localized "burned area" floods. On the last day of 1933 there occurred in the Verdugo Creek watershed of L

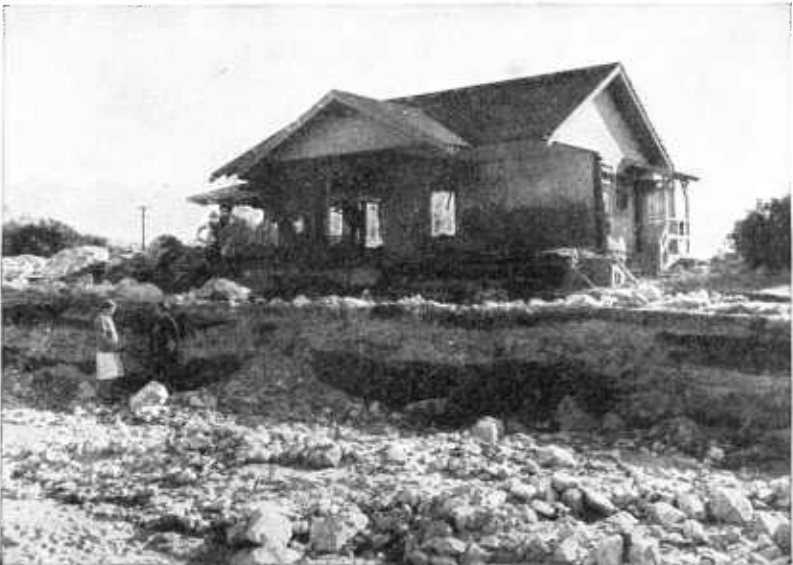
FIGURE 32.—This Montrose cottage is one of the 400 homes wrecked by the New Year's flood from the fire denuded watershed. The great gully in foreground carried away lawn and garden.

A storm of record volume, beginning on December 30, a little more than a month after a severe forest fire had swept the mountain slopes above the valley and reduced their chaparral cover to ashes, poured 12 inches of rain upon the steep and barren slopes within a period of 56 hours. The ensuing mud flows reached their climax at midnight on New Year's Eve and swept through the towns of La Crescenta, Verdugo, and Montrose in numerous streams with such force that boulders weighing from 20 to 50 tons were carried thousands of feet and deposited on the city streets. In each stream path suburban homes were wrecked and their gardens either gouged away by deep gullies or buried under mud and boulders (fig. 32). In the small resi-

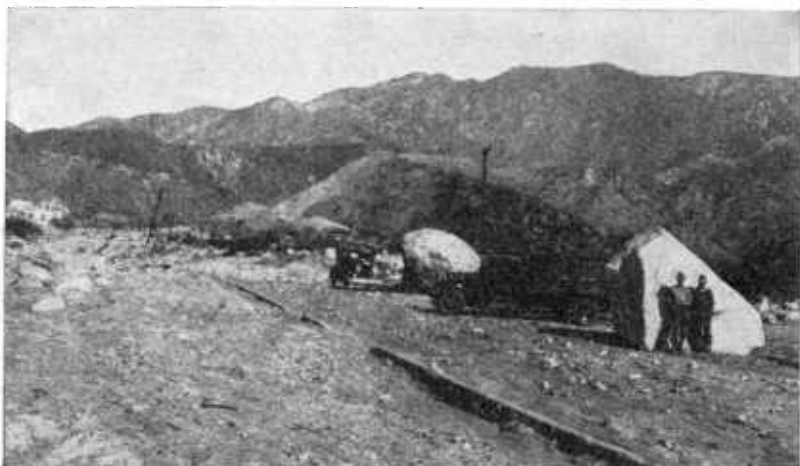
FIGURE 33.—Boulders weighing 60 tons each deposited on a street of La Crescenta by the New Year's flood from Dunsmere Canyon.

dential valley of La Crescenta 34 persons were swept to their death, and property, including more than 400 homes, was destroyed or damaged to the extent of \$5,000,000 (fig. 33).

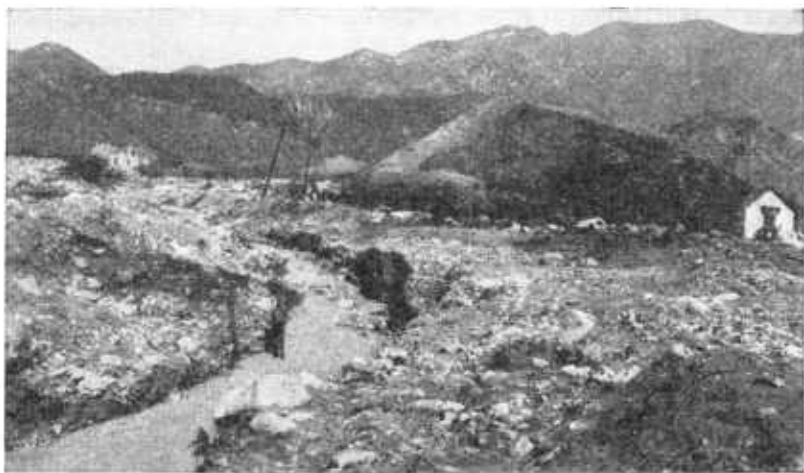
FIGURE 34.—Dunsmere Creek, ravaged by flood from the burned area. Line of boulders near the building indicates extent and force of the torrent. All trees were torn from the stream banks, and rock-mattress check dams were swept from its bed. Man stands near the remains of one of the wire-bound dams. Compare with figure 35.

The peak run-off of water in streams from the burned area was conservatively calculated at 500 cubic feet per second per square mile, plus at least an equal volume of solids, making a total flow of 1,000 second-feet per square mile of watershed (fig. 34). In striking contrast, the simultaneous peak flow from the well-forested Arroyo Seco watershed, contiguous to the burned area, was only 58 second-feet per square mile, although rainfall in the Arroyo was 14.85 inches, or more than 2 inches greater than in the burned area. In the San Dimas Experimental Forest, 20 miles east of La Crescenta Valley, several well-forested unburned watersheds yielded peak flows averaging only 53 second-feet per square mile from 10.8 inches of precipitation.

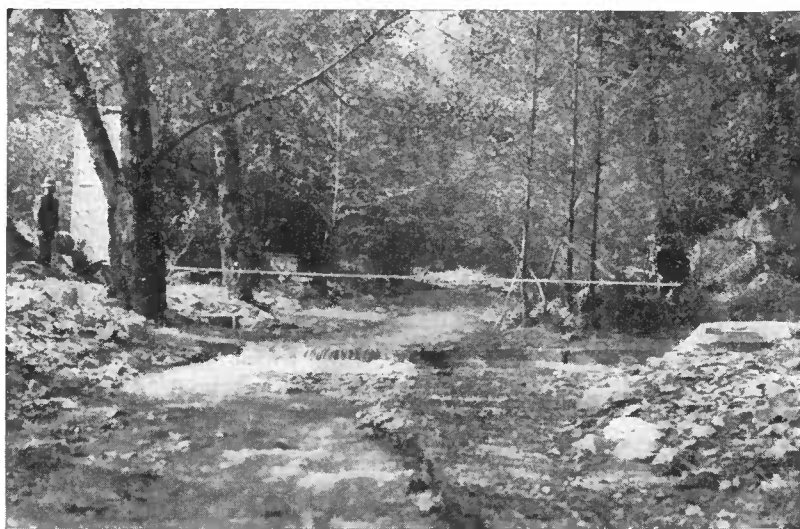
FIGURE 35.—Arroyo Seco Creek, undamaged by storm run-off from forest-covered watershed adjacent to the burned area. White line shows high-water mark of the New Year's storm. The water, being clear and controlled, was harmless. Compare with figure 34.

In the unburned watersheds, however, erosion debris caught by reservoirs of the experimental forest amounted to only 52 cubic yards per square mile. Erosion measurements from Arroyo Seco were not obtainable, but forest officials reported that the high water of that creek was practically clear and that the small amount of silt which it carried came directly from the gulying of a newly-built highway in the canyon. The condition of the creek bottom after the storm (fig. 35) verifies this observation and indicates that erosion rates in the Arroyo Seco must have been very similar to those in the San Dimas area.
